November, 19 2019 M2 Update

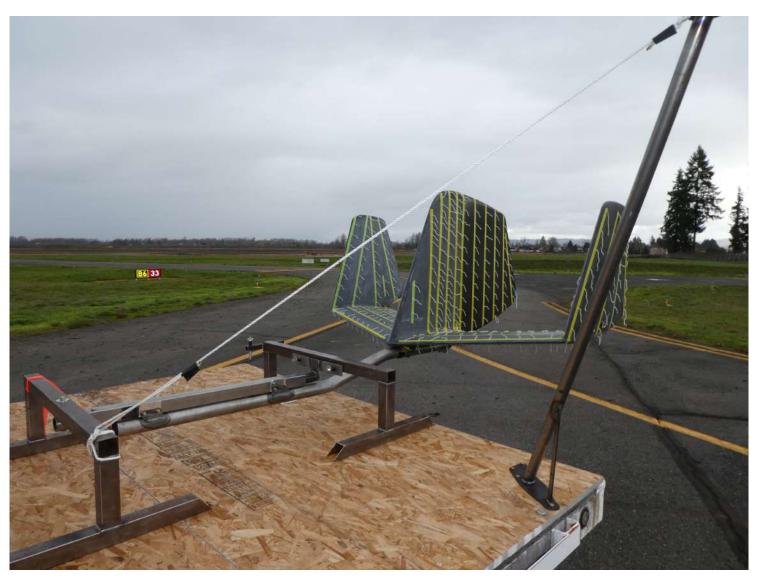
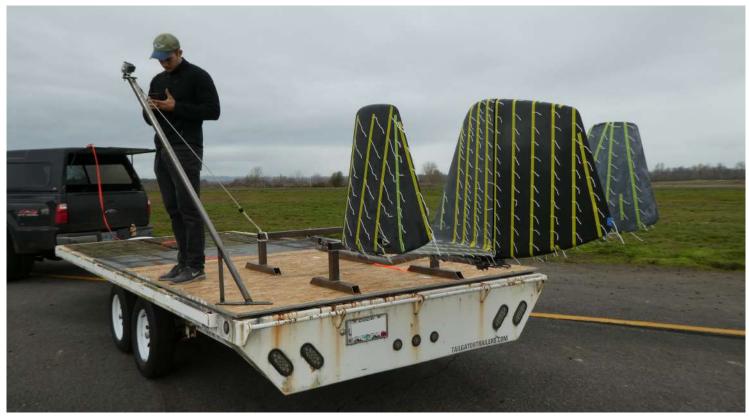
First test of the tufted M2 tail (still shot from GoPro video at ~80mph). Air is evenly hugging the surfaces. Noticeable to us was the aerodynamic force of the tail.
